Sewer scope inspection report
Prepared by: Bryce A. Kibbey
Prepared for: John & Jane Smith
Address: 12345 Main St., Anytown, TX 99999
Date of inspection: 6/30/2025

Introduction

A sewer scope inspection was requested for the property listed/pictured above. This inspection involves sending a camera down the building sewer/lateral line from a readily accessible area (3" or 4" cleanout etc) to the city main or private sewer connection.

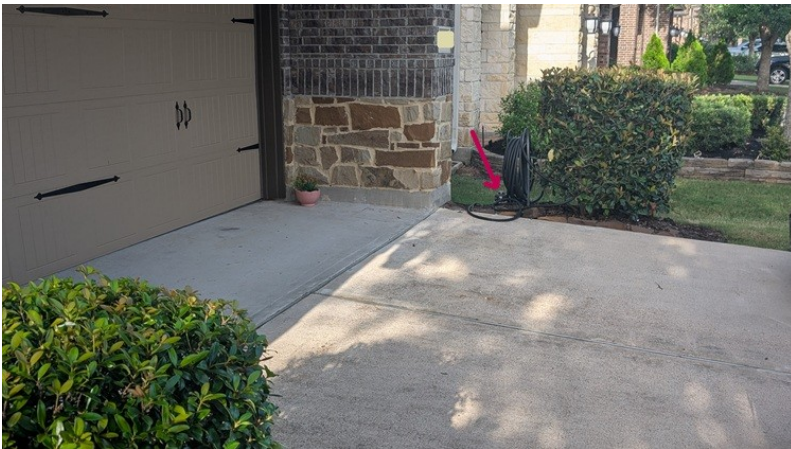
Main Sewer cleanout location (T fitting / non swooped). Northwest corner of building

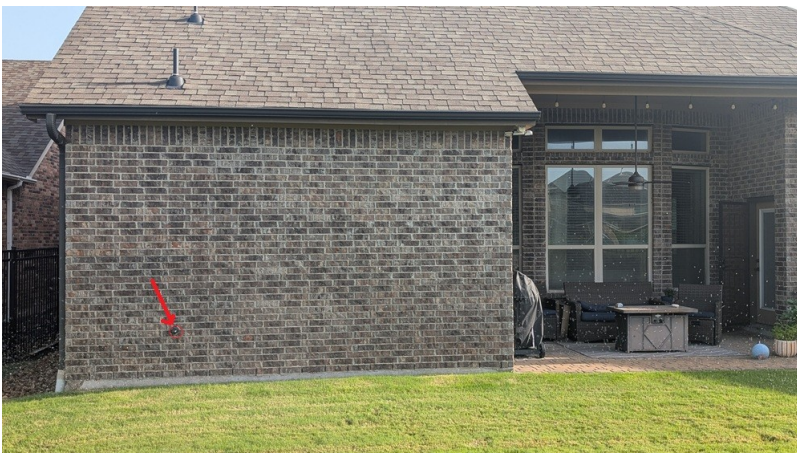
Secondary underslab cleanout location (not inspected). Southwest corner of building.

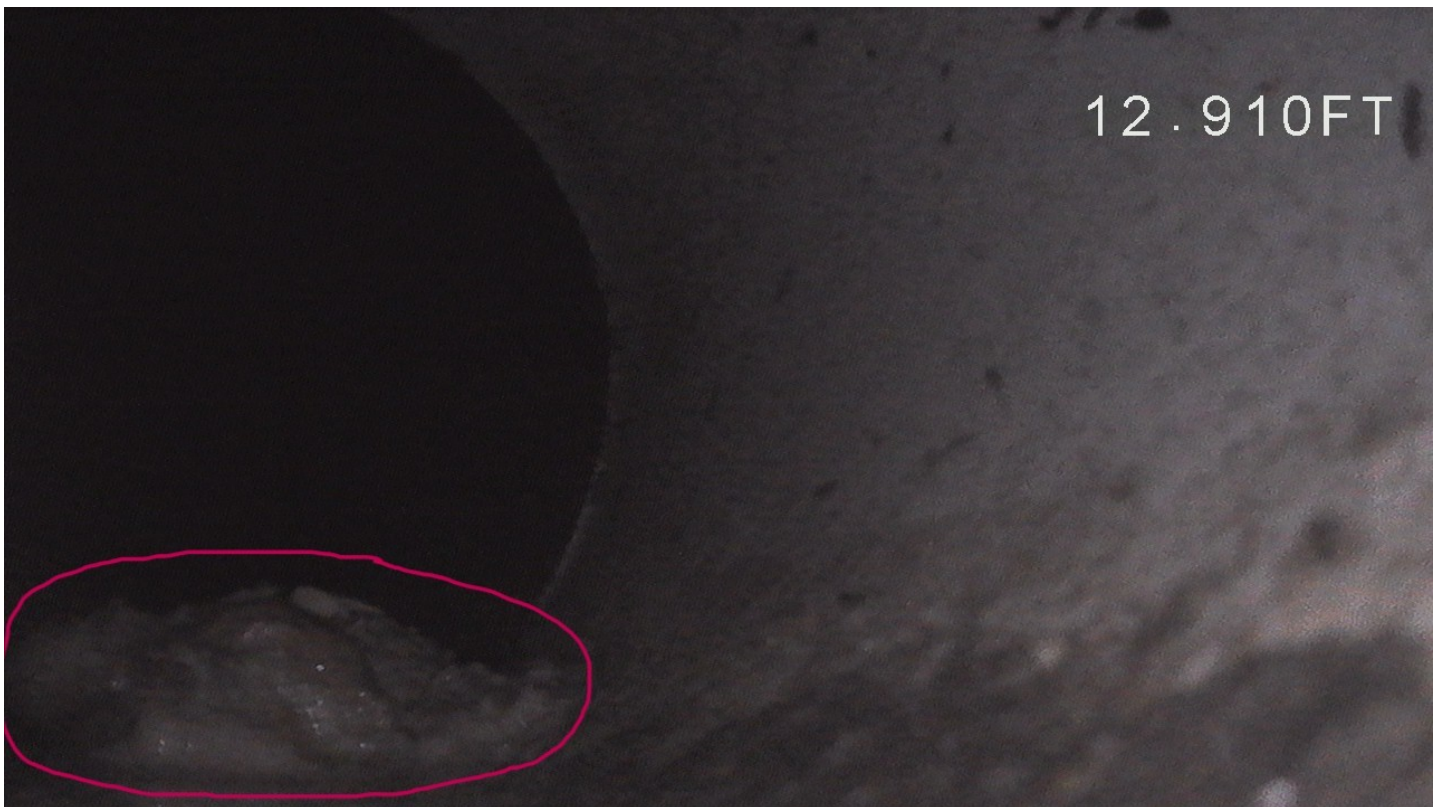
A buildup of fatty sludge was observed at various points of the line (reference video links above and photos below). A significant build exists at the transition point from the residential main sewer line to the city line. This can be seen at the end of Video 3 and also the photos below. This is likely due to the disposal of cooking grease through the kitchen drain. Even if large amounts (such as disposing of bacon grease after cooking) are not disposed, the act of washing greasy pans, dishes and utensils will contribute to a slow build up over time. Oils from human skin shed during showers/baths can also slowly accumulate.

Sludge build up – transition to city sewer line – approximately 129 ft.

To treat the sludge build up in the line you should consider using a bio-microbial agent such as BioOne (<https://bioonesolutions.com/>). These are products that “feed” on the sludge buildup in sewer lines and essentially slowly eat it away. Application instructions typically call for one, two or three treatments a year. For BioOne you can simply flush it down a toilet for example.

Products of this type typically cost from \$30 - \$50 for a supply that if used according to directions will last years. An alternative to using a bio-microbial agent to treat the sludge would be to use a hydrojet service that many plumbing companies can provide. This entails using a high pressure stream of water to clear the sludge away and move it downstream to the city sewer connection.

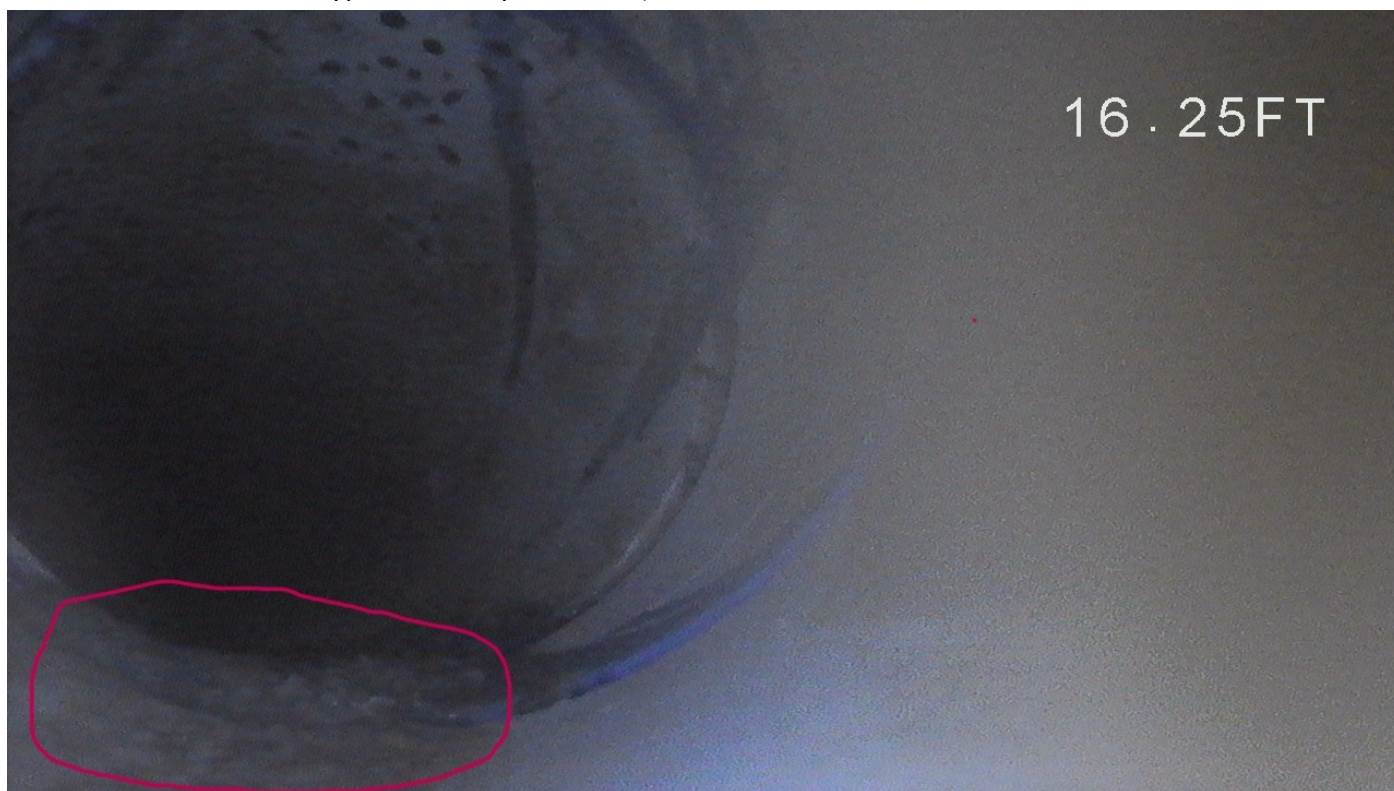
Sludge buildup – approximately 16ft. (This is just one example. In the videos there are several locations where this type of buildup is visible.)

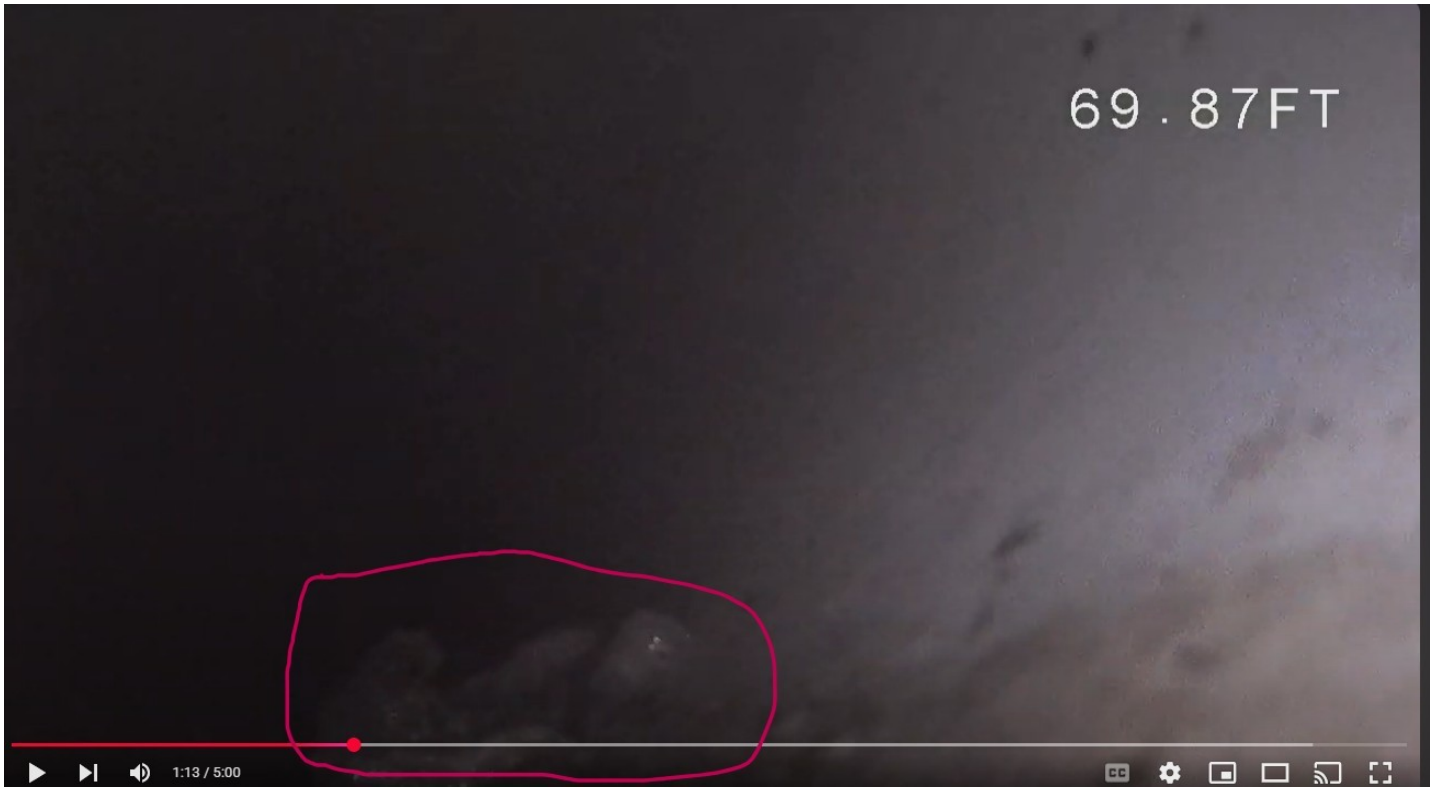
A piece of what appears to be cellophane wrapping from a consumer product is stranded in the line at around the 69 ft mark and can be seen in Video 2, the camera head dragging it along for some time afterwards.

Plastic wrapper – approximately 69ft.

For the piece of cellophane, while not really retrievable there is a possibility, while remote, that it could get stuck permanently in the sludge buildup and impair the overall functional flow of the sewer line. It may be possible to move it downstream to the city sewer connection by introducing a higher than normal water flow to

the sewer line. This could be done by running multiple faucets/fixtures in the house simultaneously while also dropping a hose running full open into the main sewer cleanout. This volume of water may serve to “float” the cellophane downstream towards the city sewer connection. Since the sewer line makes many turns on it’s way to the city connection, it may be necessary to maintain this higher flow condition for up to 20-30 minutes to move the cellophane to the city connection.
