# PROPERTY INSPECTION REPORT

**Prepared For: John Smith and Jane Smith  
12345 Main St, Anytown, TX, 99999**

**Date of Inspection: 7/1/2025  
Year Built: 2014 Size: 3400 sq ft  
Weather: calm/clear**

**PROPERTY INSPECTION REPORT FORM**

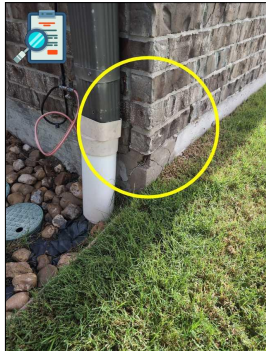
There are one or more corner pops found on the corners of the homes foundation. While these are rarely a structural concern, repair is recommended. After repairs are made continue monitoring these areas and additional repairs undertaken as needed.

Example of a corner pop on the southwest corner of the homes foundation where repair is recommended.

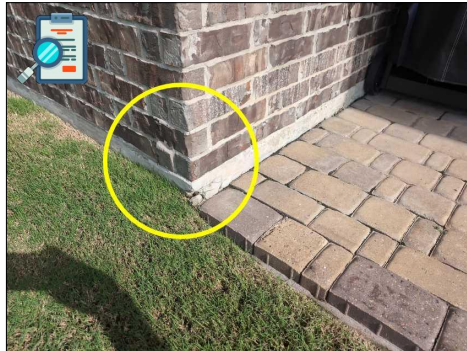
Example of a corner pop on the south-central area of the homes foundation where repair is recommended.

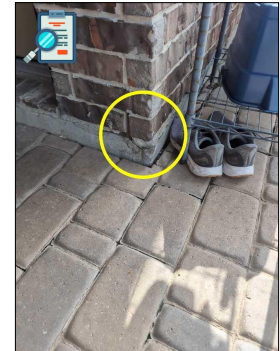
Example of a corner pop on the south-central corner of the homes foundation where repair is recommended.

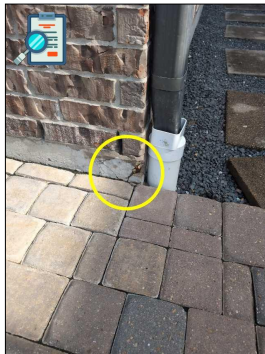
Example of a corner pop on the southeast corner of the homes foundation where repair is recommended.

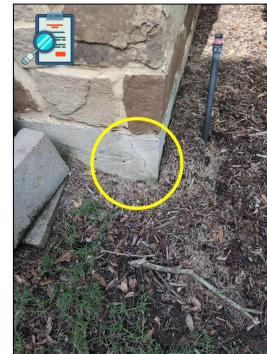
Example of a corner pop on the northeast of the homes foundation where repair is recommended.

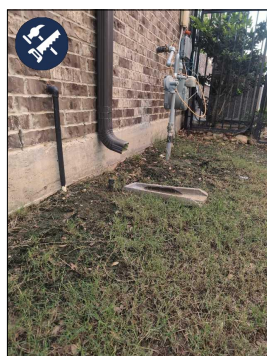
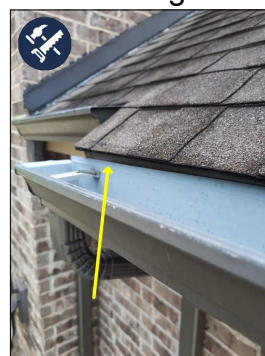
There is one splashblock on the northwest side of the building that has settled with a negative pitch back towards the house. Additional soil and/or shoring should be installed under this block to restore proper pitch and divert water away from the foundation.

Front of house above garage the gutter system. Is installed over the drip edge. This can provide a pathway for water to get behind the gutter and cause damage and rotting of the fascia. Recommend further evaluation and repair by qualified roofer or gutter specialist.

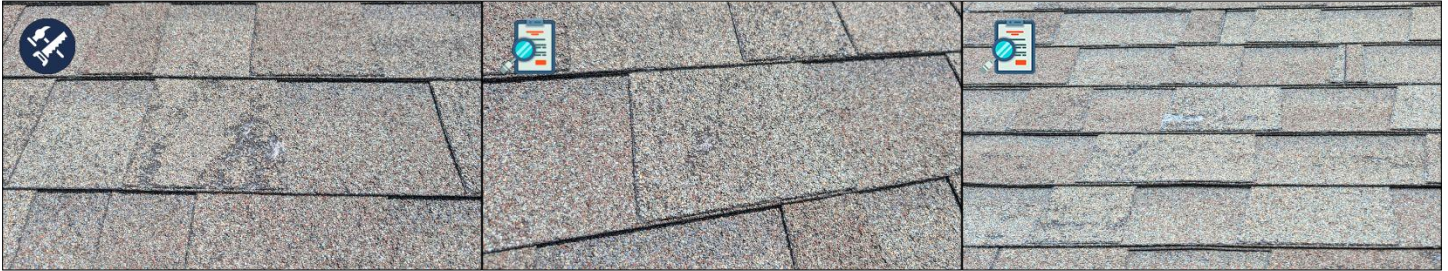
The roof appears to have possible hail damage and there are multiple areas with apparent impact spots. Further evaluation by a qualified roofing contractor is recommended and proceed as directed. South facing side of roof. Fiberglass base material is visible.

Possible hail damage. South facing side of roof. Fiberglass base material is visible.

Possible hail damage. South facing side of roof.

There is visible mildew growth on the Northside facing roof in areas shaded by gables. Recommend cleaning by homeowner or roof cleaning specialist.

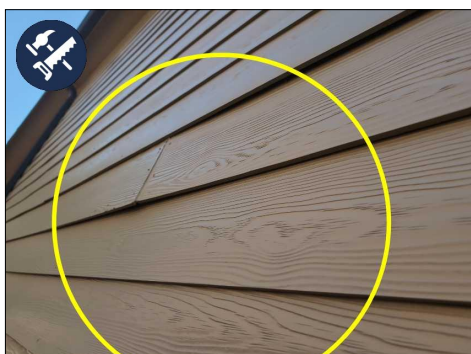
There are a couple pieces of loose cement board siding. Repair is recommended. West side of building.

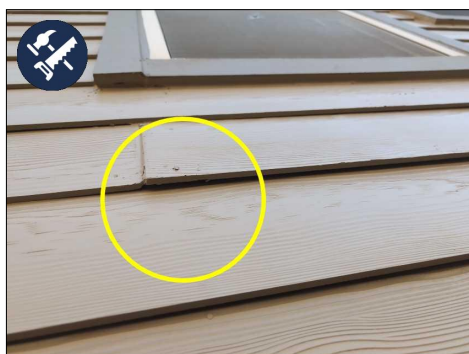
There are a couple pieces of loose cement board siding. Repair is recommended. West side of building

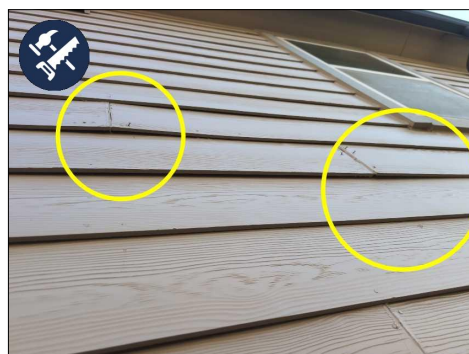
There are a couple pieces of loose cement board siding. Repair is recommended. West side of building

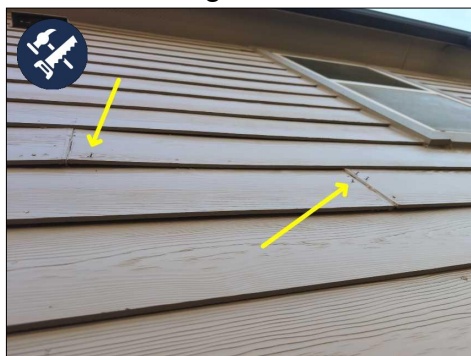
Exposed and popping nails on the cement board siding should be driven in and sealed. Repair is recommended. West side of building

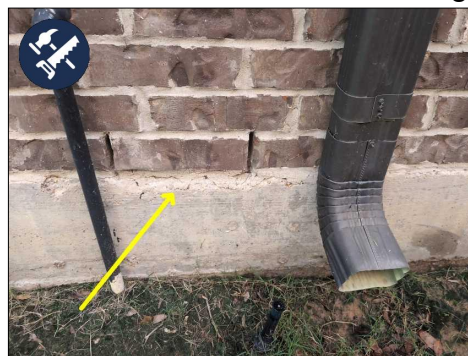
There are areas of mortar that has cracked, is missing or has gaps. Mortar improvements are recommended to prevent possible moisture penetration. West side of building.

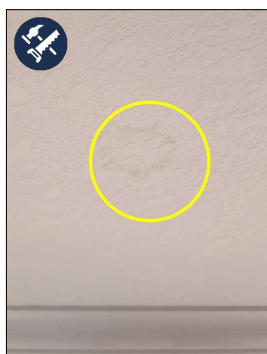
There is a 2" - 3" diameter water stain visible in the master bathroom ceiling. Testing with an IR thermal imaging camera and pinless moisture meter showed the area to be dry with no residual moisture. The homeowner informed that the water heaters were replaced "a couple of years ago" and that he believes a small amount of water may have spilled on to the ceiling drywall from above during this process. The water heater location in the attic is directly above this stain. Recommend paint repair by homeowner.

Master bathroom ceiling water stain.

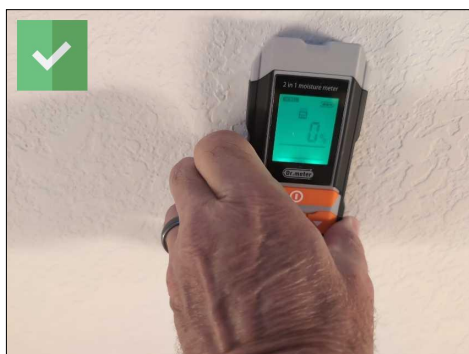
Moisture meter showing 0% moisture reading over the water stain - master bathroom ceiling.

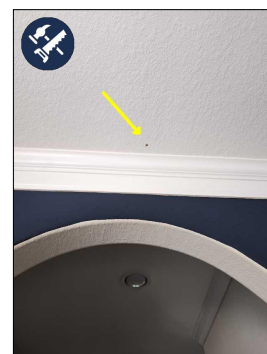
A nail pop was found in the dining room ceiling. While these are generally cosmetic in nature, repair is recommended.

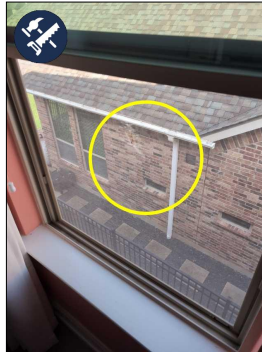
The screen on one of the upstairs bedrooms window has a hole that is in need of repair at some point in the future.

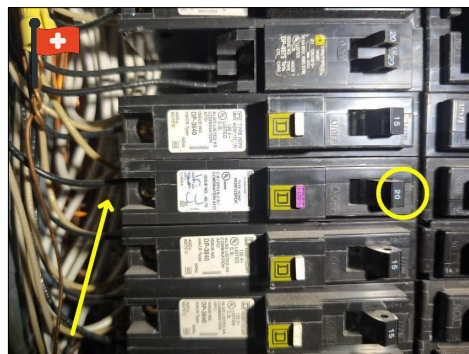
There is a wire connected to an over current protection device (breaker or fuse) that is undersized for the breaker in the main panel. This condition will not allow the over current protection device to trip and protect the electrical components. This is considered an unsafe condition and repair by a qualified electrician is recommended.

Circuit breaker #15 - 20 amp breaker with 14 AWG branch circuit wiring connected. A 20 amp breaker requires a minimum 12AWG copper wire. This is an unsafe configuration that should be corrected by a qualified electrician.

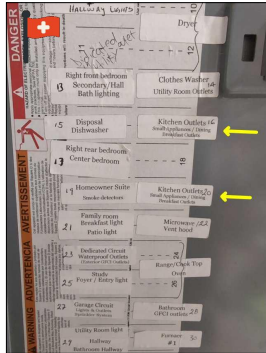
All receptacles/circuits serving the kitchen countertops should be upgraded to AFCI protected for enhanced safety.

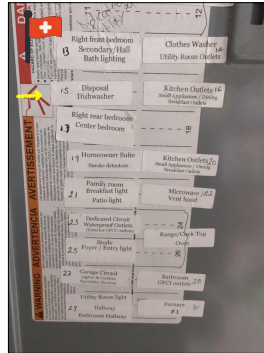
The food waste disposer circuits/receptacles and Dishwasher receptacles should be upgraded to AFCI protection for enhanced safety.

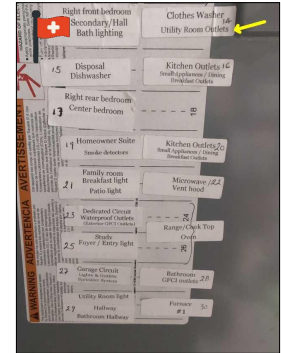
All laundry room circuits/receptacles should be upgraded to AFCI protected for enhanced safety.

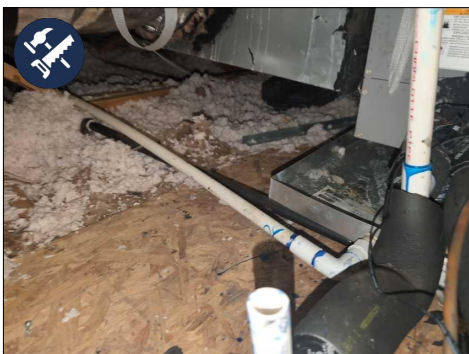
The AC secondary drain line has a negative pitch back towards the pan. This can cause water to back up in the drain pan and eventually overflow. Recommend elevating drain pan to restore proper pitch to secondary drain line.

AC secondary drain line is back pitched towards pan. This can cause water to back up in the drain pan. Recommend elevate drain pan to restore positive pitch.

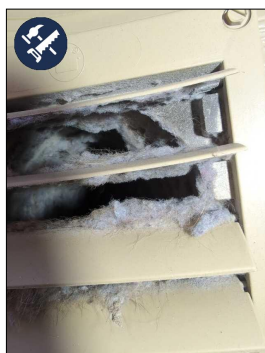
View of dryer duct from the exterior. A duct cleaning is recommended.

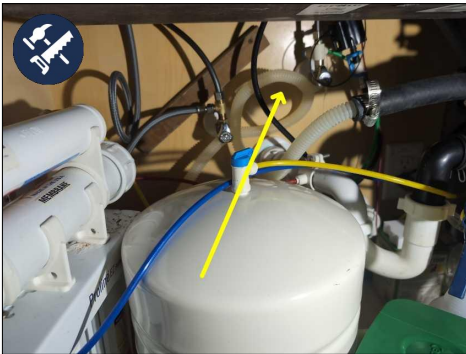
The high loop for the dishwasher should be mounted directly under the counter top in the sink base cabinet. The high loop was not mounted high enough. Some dishwashers have them build into the design, but that could not be verified. It is recommended to monitor for water in the bottom of the dishwasher and repair as needed.

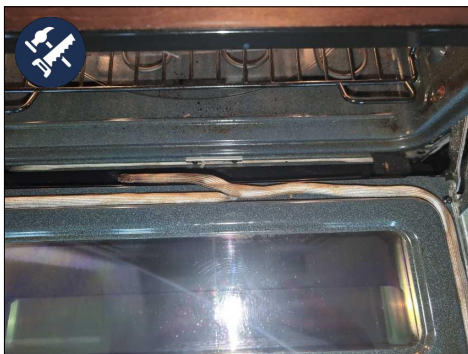
The door seal for the oven is loose, it did seal adequately and should be repaired.

Loose oven seal upper oven.

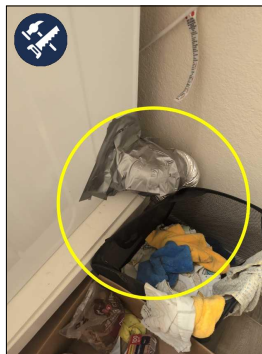
The flexible dryer vent connector to the dryer vent was secured to the dryer with duct tape. This should be removed and secured with foil HVAC tape.

Dryer flexible vent connector secured with duct tape. Remove/replace with foil HVAC tape.
