Mold inspection report  
Date of inspection: 7/7/2025  
Prepared by: Bryce A. Kibbey  
Prepared for: John and Jane Smith  
Address: 12345 Main St., Anytown, TX 99999

A Complete mold assessment and testing was performed on 7/7/2025 by Bryce A. Kibbey, Owner of Gumshoe Property Inspection LLC. The subject property is located at 12345 Main St. in Anytown, TX.

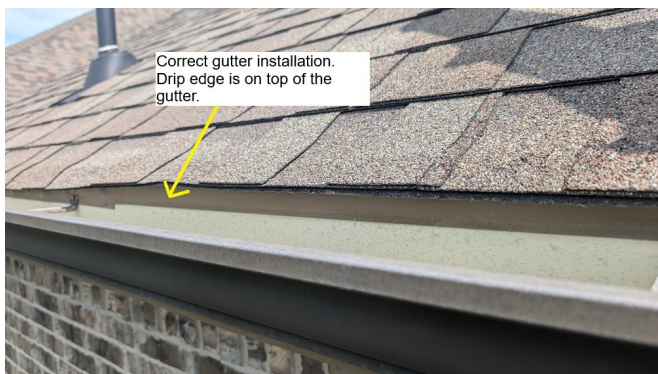
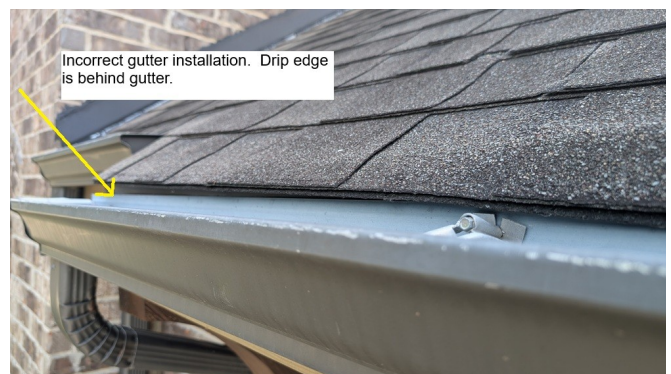
The gutter system on the north side of the building above the garage has a deficiency where the gutter is laying on top of the drip edge rather than underneath the drip edge. This creates an environment where water draining off of the roof or wind driven storm water can get between the gutter system and the fascia. This can lead to premature fascia deterioration, mold growth, and water penetration to the attic. It is strongly advised to have this condition corrected. In the two pictures below, the left picture shows the gutter installation on the south side of the building and is done correctly. The right picture shows the gutter installation on the north side over the garage.

- Follow up on the recommendations for the roofing material and roof drainage systems found in the Inspection Areas & Summary Findings section.
- Follow up on the recommendations for the fiber cement siding material found in the Inspection Areas & Summary Findings section.
- Homeowner should perform a visual inspection of the roof and attic framing and decking material annually as a way to spot moisture intrusion problems early on.
- Homeowner should be vigilant in maintaining door/window seals and weatherstripping. This will help keep the home “tight” and keep mold levels low. “Drafty” homes tend to have more mold management issues than tight homes.

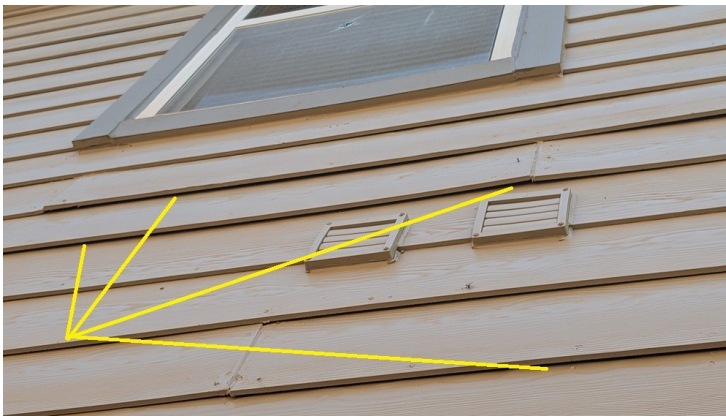
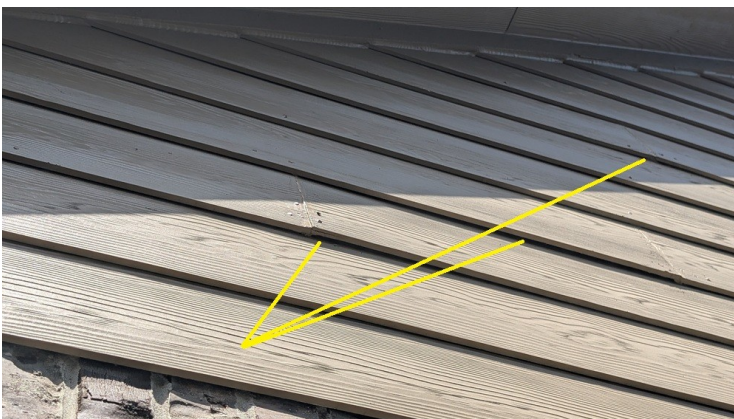
**Cladding, flashing & trim** – There are multiple areas on both the west and east sides of the building where the fiber cement board siding material is pulling away from the building. As this condition continues it will create opportunity for wind driven storm water to get behind the siding and potentially lead to mold growth. It is recommended that the homeowner consult with a siding specialist to correct this condition. In the photos below, the top photo shows some of these areas on the west side of the building. The photo on the bottom shows some areas on the east side of the building.

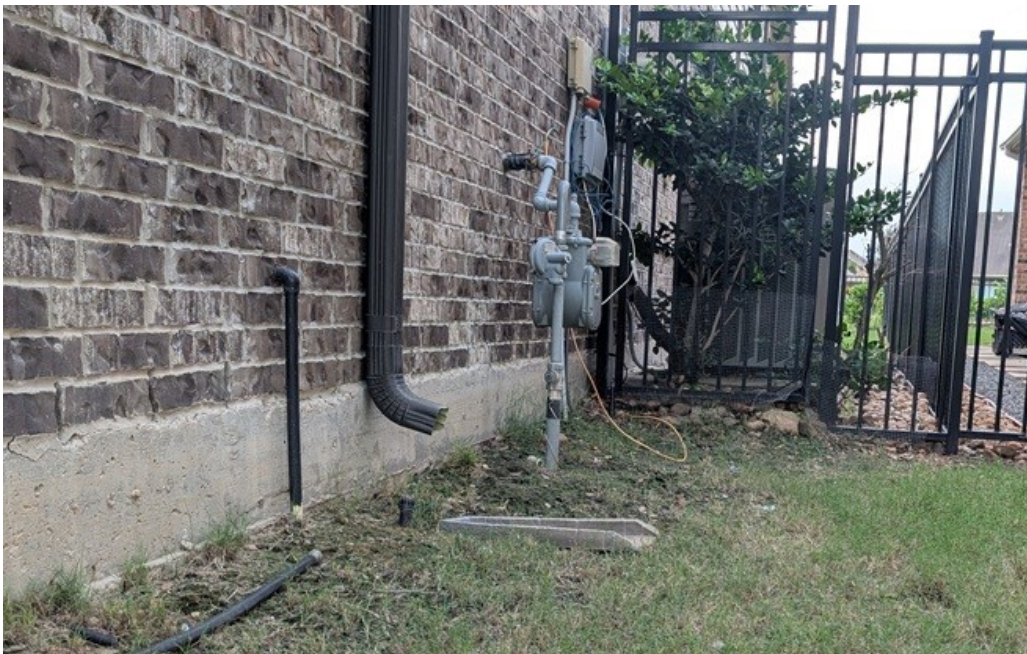
**Exterior grading** – Exterior grading is sufficient for proper drainage away from the building. On the northwest side of the building there is one splash block that has settled into the soil resulting in a negative pitch back towards the building. It is recommended to shore up this splash block to return positive pitch and direct water away from the building. The photo below shows this splash block and the back pitch condition.

Splash block pitch should mirror the general grading pitch so that water is directed away from the foundation so that the foundation is kept as dry as possible.

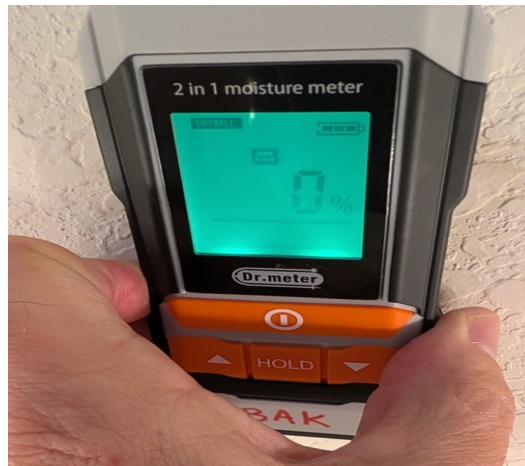
**Walls, ceilings, floors, doors & windows** – In the master bathroom on the ceiling there is an approx. 2" – 3" diameter water stain visible. This is directly below the location of the twin water heaters. The homeowner was present and explained that when the water heaters were replaced "around 3 yrs ago" a small amount of water leaked out of one of the water heaters in the process of replacement creating this stain.

An examination of this area in the attic revealed no current moisture exists and a pinless moisture meter placed over the stain revealed a moisture level of 0%.
